AIA Document G704™ - 2000**Certificate of Substantial Completion****PROJECT:**

(Name and address)
Oak Creek Village Apartments
2324 Wilson Street
Austin, Texas 78704

CONTRACT FOR: General Construction
CONTRACT DATE: May 21st, 2014

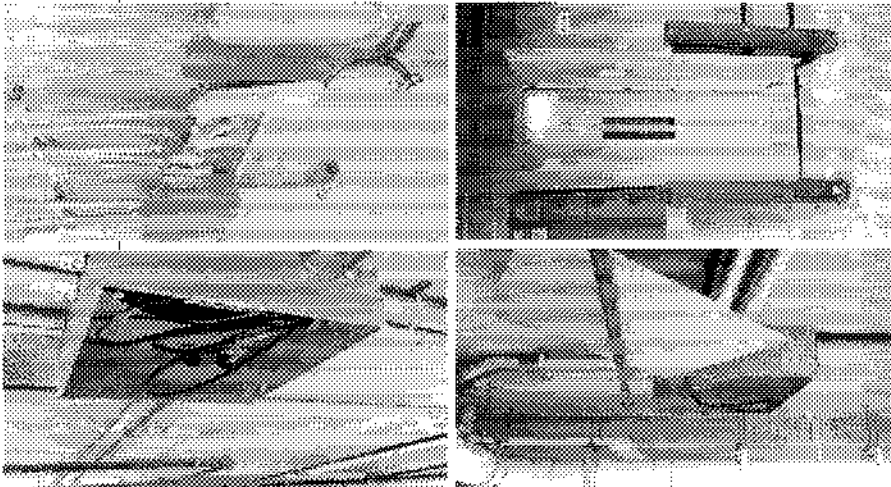
<ul style="list-style-type: none"> - Several open ceiling mounted boxes observed. - Chain of boxes partially open with plastic-jacketed wiring exposed. - Large elec panels on east wall of stairwell are unlocked - Bollards protecting elec panels are empty, unpainted, uncapped. Fill w/ conc, cap & paint.

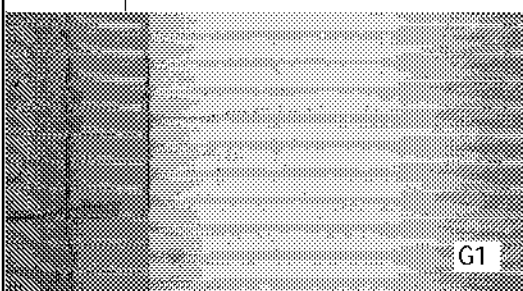
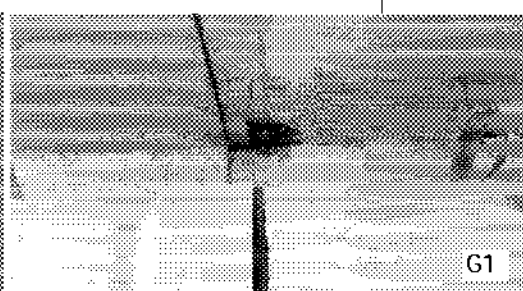
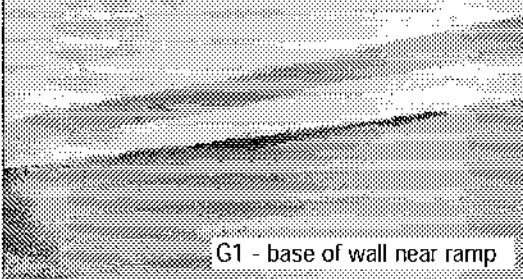
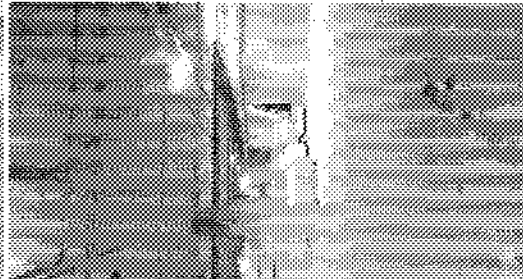
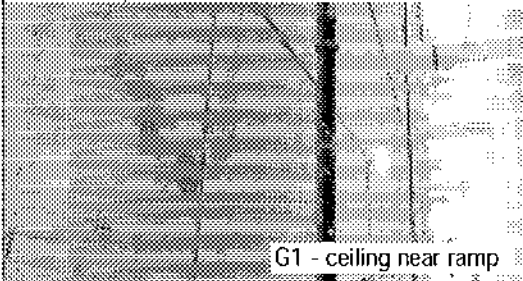
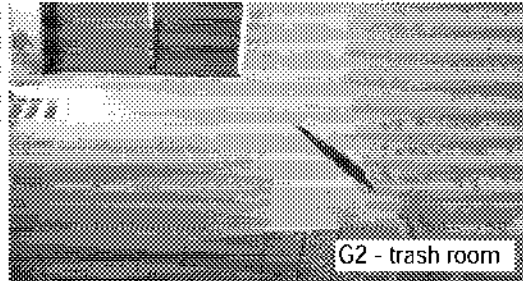
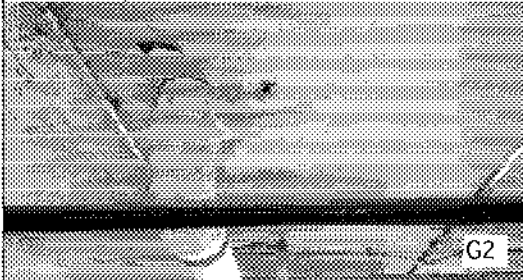
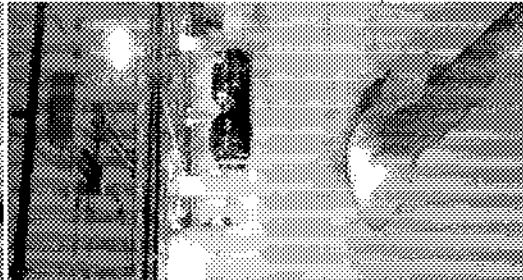
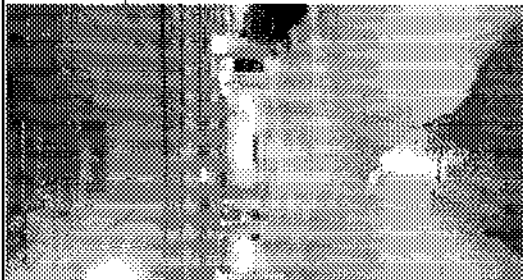
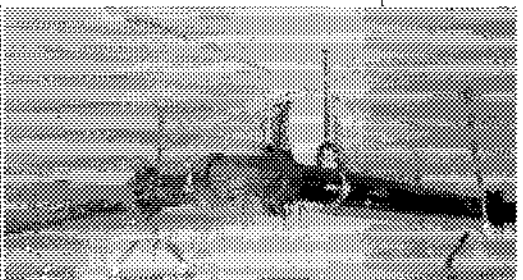
Location	Date	Description	Photos
Leaks, All		Many locations exhibit signs of water intrusion, on both levels, usually at the top of wall/ceiling joint. Photographed locations are perimeter walls unless noted otherwise

G1 - ceiling drips near elevator, originating from G2 ceiling directly above

G2 - water dripping @ rapid rate from electrical boxes

G2 - location of previously discussed leak (below entry sidewalk) still leaking

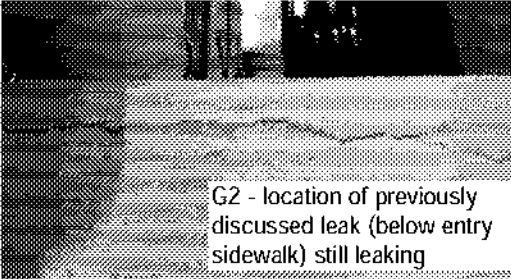
Leaks, All

<p>G2 - location of previously discussed leak (below entry sidewalk) still leaking</p>

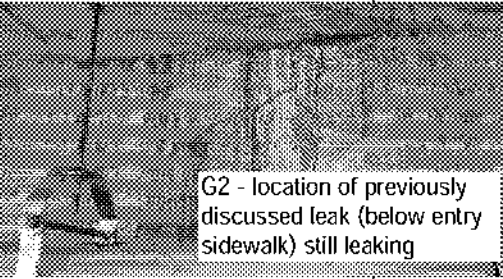
<p>G2 - location of previously discussed leak (below entry sidewalk) still leaking</p>

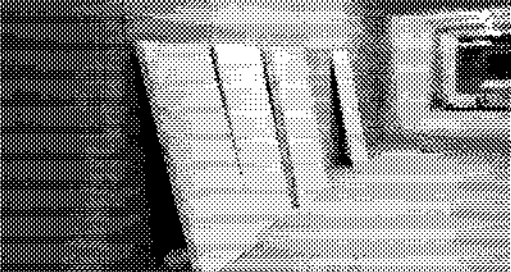
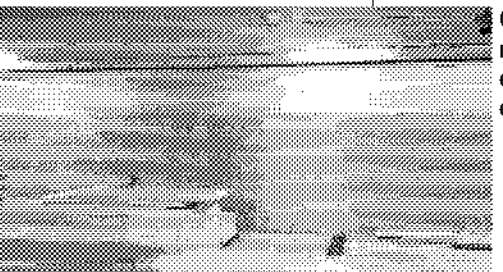
<p>Coordinate with owner for removal of extra material - doors, sheet metal, concrete core (SW corner), steel, etc.</p>
Floor

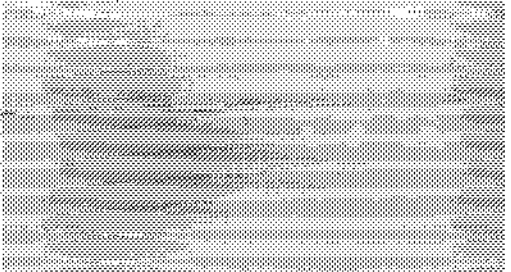
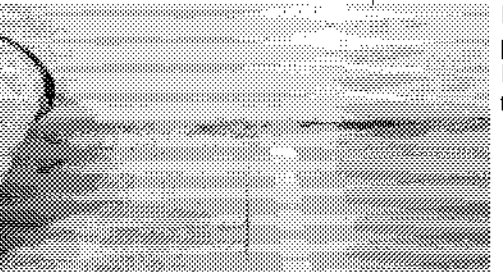
<p>Loose filler strips @ floor perimeter are coming up. Remove concrete/mortar drops throughout</p>

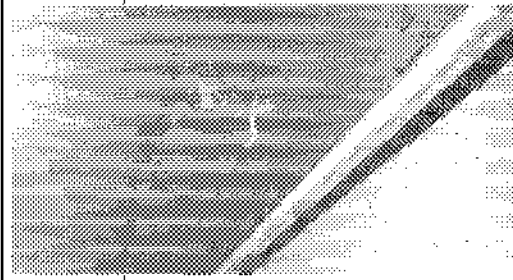
<p>Several locations have plastic sheeting either adhered or embedded into concrete. East perimeter wall of G2, West perimeter wall of G2</p>
Maintenance / Splash Pad Room

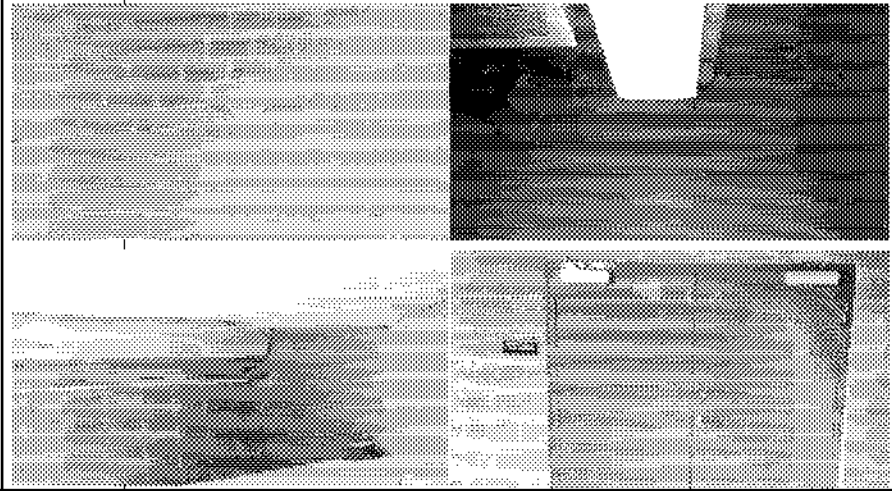
<ul style="list-style-type: none"> - Remove effluorescence staining @ bottom course of CMU from equipment leak. - Replace molded door frame & damaged bathroom door. - Finish bathroom interior. Paint all gyp surfaces, clean-up / replace damaged wall board. - Double door doesn't latch securely - can be pulled open when locked. - Overwhelming chlorine/chemical odor present. Exhaust system does not seem to be running properly or is not adequate for equipment. Confirm proper operation.

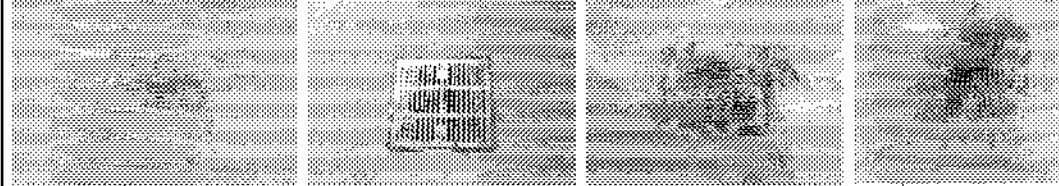
Floor Drains

<p>Replace obstructed, stained or otherwise less-than-new quality drain grates. Trim back or remove excess fabric material around grates.</p>
Accessible Signage

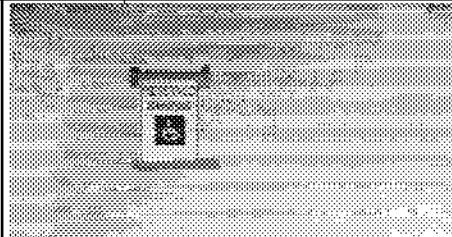
<p>Install wall mounted signage.</p> <p>Confirm that G1-level Van Accessible signage & striping was installed, to compensate for lack of adequate vertical clearance on G2.</p>

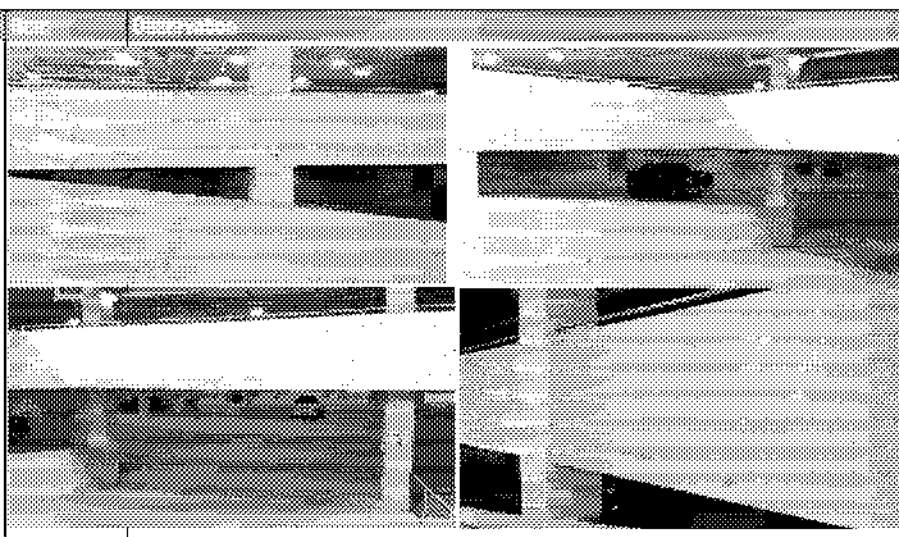
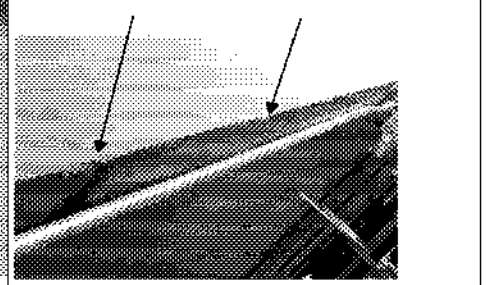
G1 Ramp

<p>Re-float scarred and scratched vertical concrete surfaces surrounding G1 entry ramp. Chamfer bottom edge of G2 half wall approx 1/2" to remove small chips and breaks.</p>

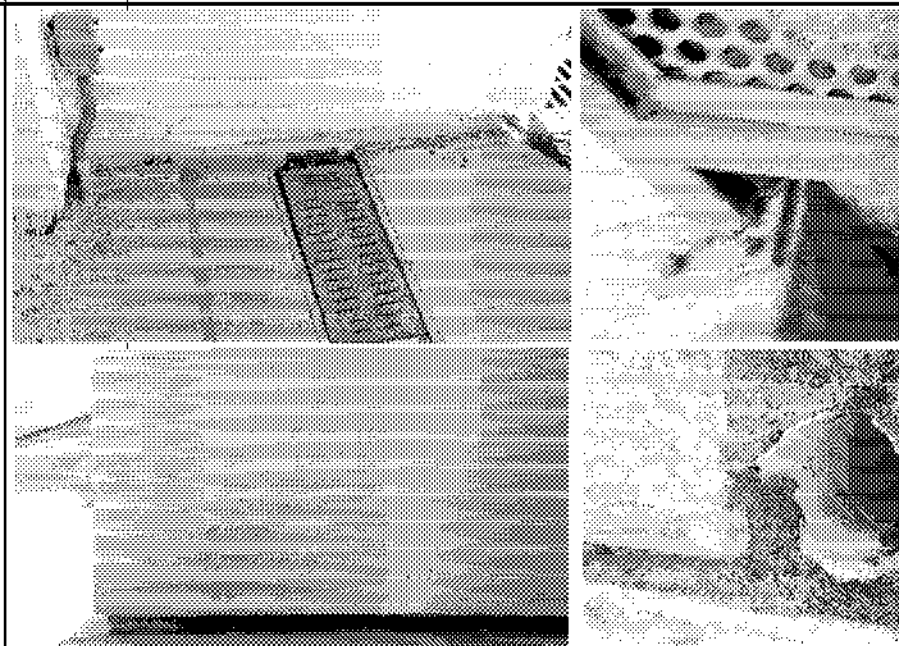
Misc

<ul style="list-style-type: none"> - Trench drain @ entry: OSB piece @ east side of drain protrudes up above grate. Grate appears to stop more than 1" short of opening on that end. How is train channel waterproofed and terminated on this end? - Guardrail paint incomplete @ Stair A South. - West wall of main entry: concrete splatter on stucco. The appearance of the waterproofing below stucco termination is unacceptable and cause for concern - why is it stained black/brown and patchy in appearance? - Cut off PCV weeps @ retaining walls cleanly.

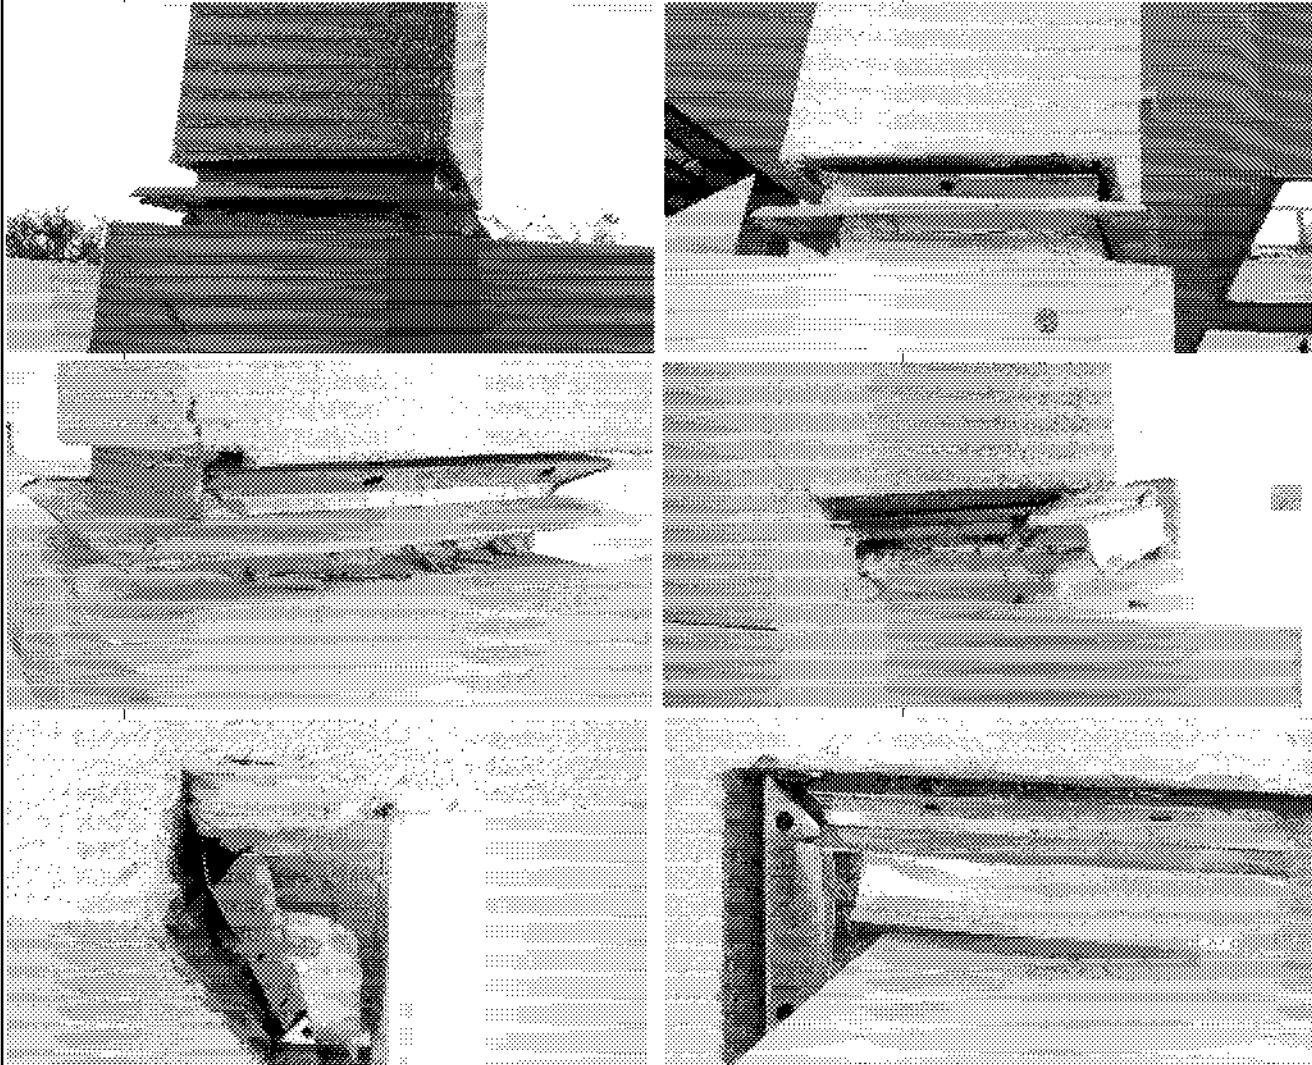
Location	Time	Observation	Notes
Stucco flashing details		Stucco wall-to-parapet cap flashing details are unacceptable, aesthetically and functionally (waterproofing). Badly cut flashing & sheet metal, large gaps, visible weather barrier fabric and sheathing, wads of sealant that do not fully close flashing gaps, missing stucco termination profiles, and sharp exposed edges are common. Remove defective work in it's entirety and replace.

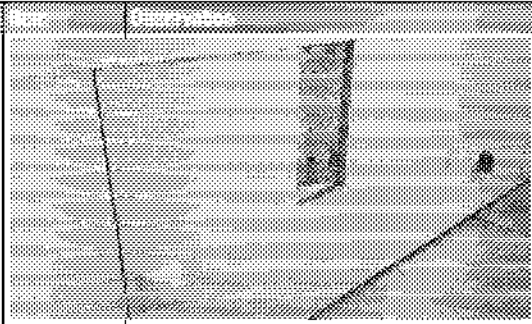
Bldg 2, level 5

Missing FEC & extinguisher. Remove over-exposed weatherproofing, and any water/weather-damaged materials underneath. Notify Owner/Architect of any signs of water penetration into the wall assembly. Replace all damaged material, w/ complete tie-in to surrounding weather barrier & flashing per all mfrs recommendations. Install specified FEC & extinguisher, keyed to match others.
Breezeway floor

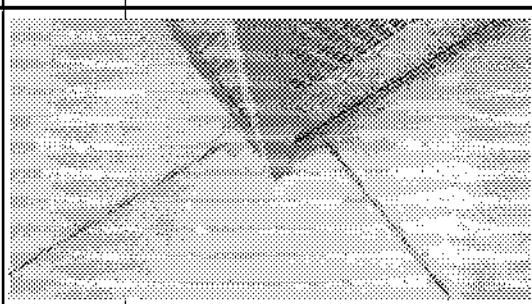
Typical: Along all breezeway railings, concrete patches at vertical supports was done in two ways: neatly cut-out square patch, and floated-in, not square, not cleaned up. The neatly cut patches appear to be holding well, while the loose patches are nearly all cracking apart, allowing water to penetrate below the surface. Redo all cracked patches.
Bldg 2

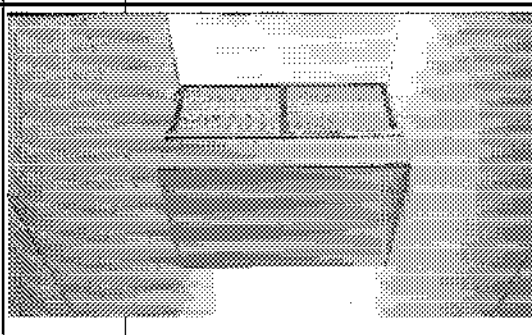
Large gap visible between top of stucco wall covering, and aluminum extrusion/flashing. Extend stucco up under flashing.

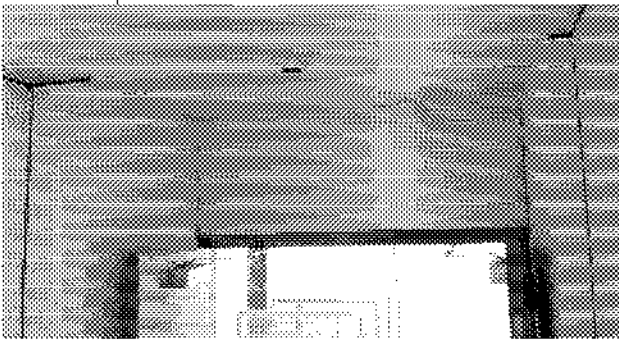
Bldg 2

Top of wall trim detail was not installed in some locations. Is this for fire-rating reasons?
Typical breezeway

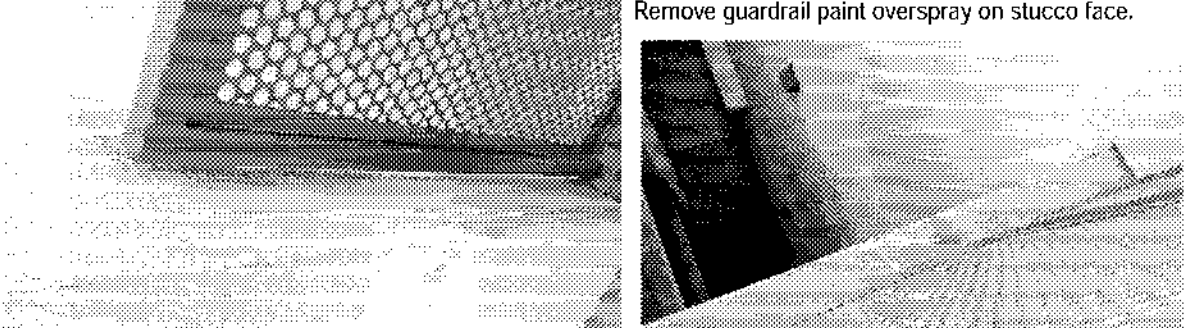
Remove guardrail paint overspray on stucco face.
bldg 4, south

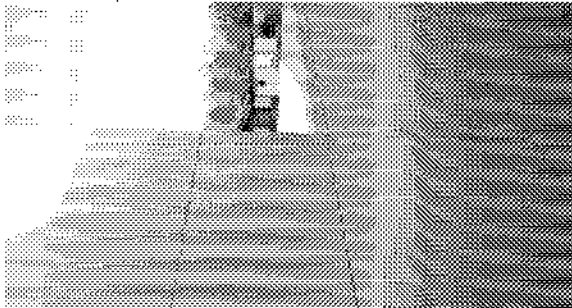
TPO piece protrudes beyond edge of stucco wall and doesn't seem to be tied in or terminated.
bldg 4, south, level 5

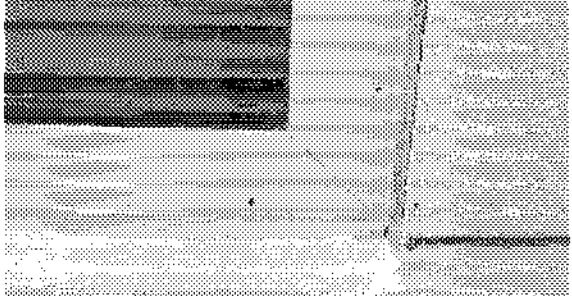
10-16 small holes drilled around perimeter of fire-rated glazing frame, showing rust-colored staining inside. Other similar windows do not appear to have these. Provide evidence that this is a factory-installed feature, intended to remain open & exposed, OR if this is a field-modification, provide mfr note certifying that window assembly fire rating has not been compromised.
bldg 3, north, level 6

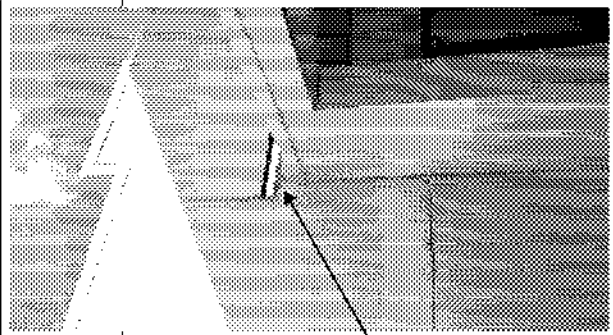
Poor stucco transition joint - lacks termination piece, not straight or plumb

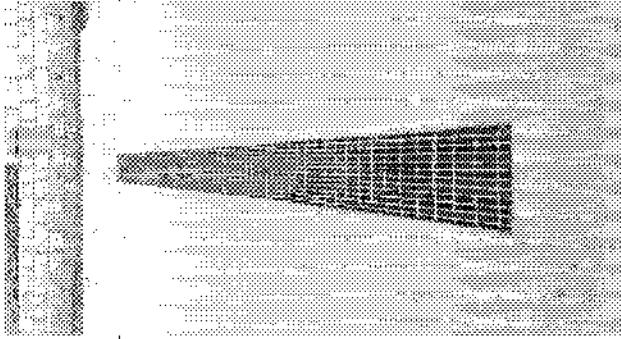
Podium, South

install heel-proof grate (match trench drain @ main entry) for accessible route, per IBC/TAS
